# Maryland Inventory of Historic Properties

MIHP Number: QA-70

Property Name: Steele House

## INVENTORY FORM FOR STATE HISTORIC SITES SURVEY

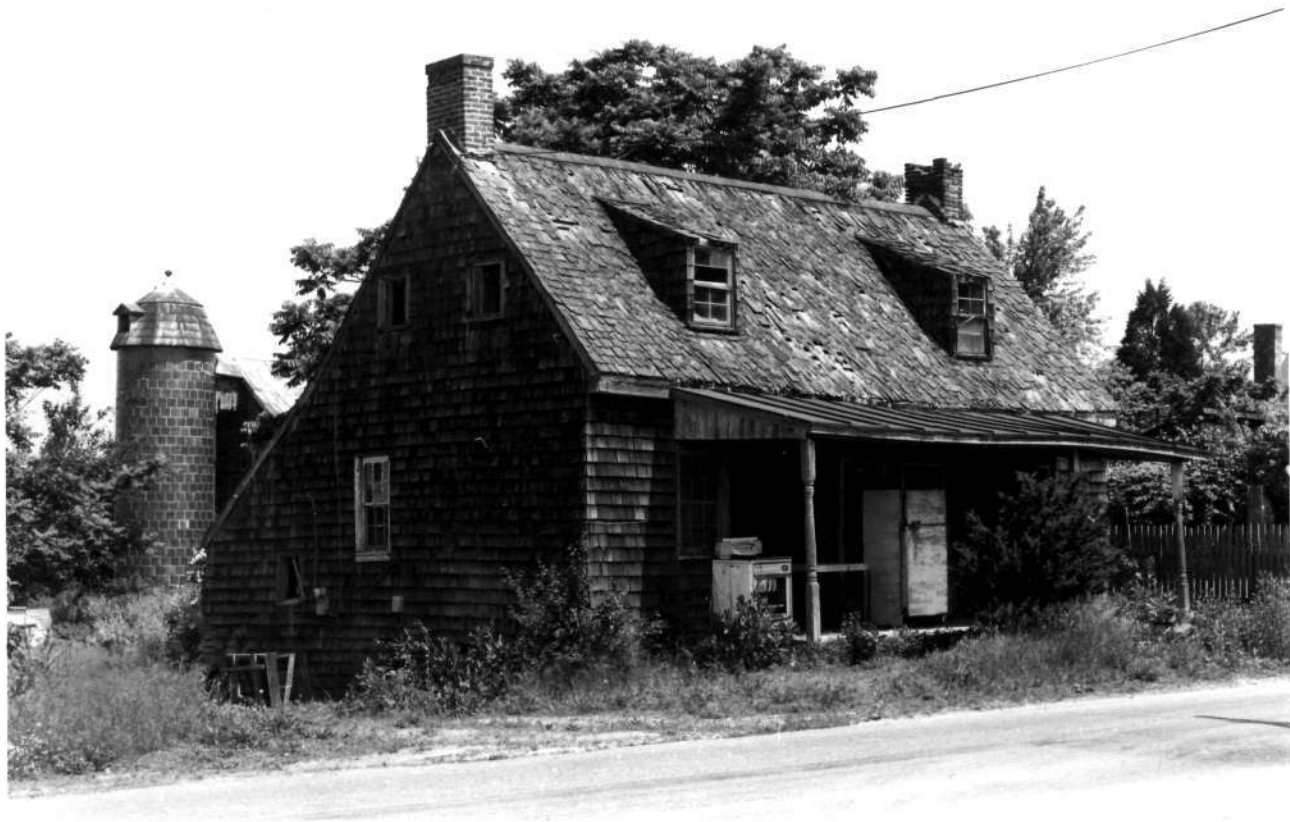
QA-70

The front facade faces southeast, directly adjacent to the road. There are two doors in the center of the facade and one 6/6 window to left and right. Two 6/6 shed roof dormers are positioned on the second floor. The house is covered with wood shingle siding and roofing, and rests on a continuous brick foundation. The eaves are boxed in but are otherwise left plain. A one story open porch protects the majority of the front facade.

Irwin Steele House  
Ingleside, Maryland  
Orlando Ridout V 1980  
Front facade from South

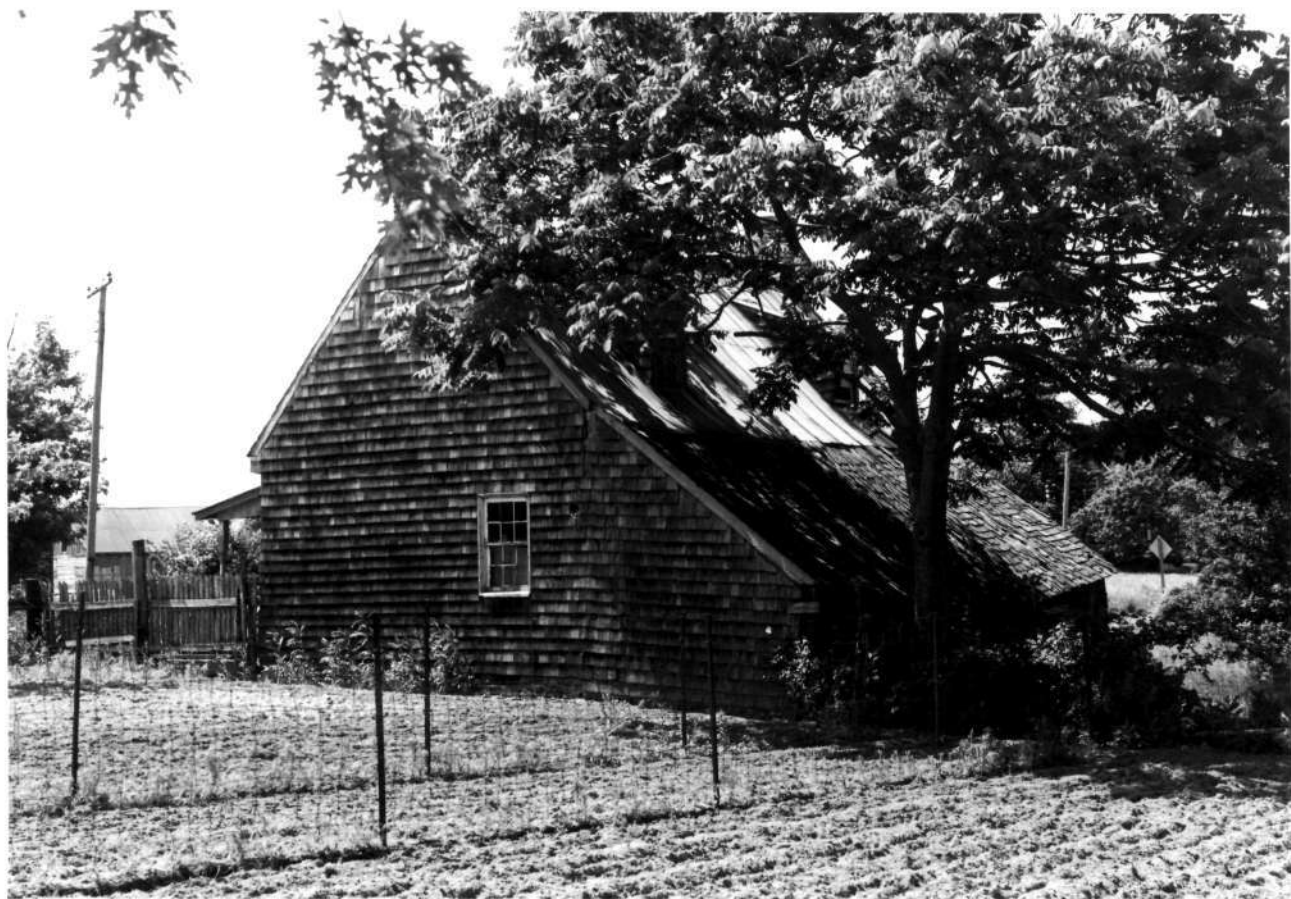
QA-70

The center portion of the rear outshut has partially collapsed. Evidently there were two batten doors near the center of the wall, with two six-light windows to the left and one to the right. There are two 6/6 shed dormers on this facade. The roof changes pitch, softening slightly over the outshut to allow more headroom at the rear. The upper pitch of the roof has a layer of corrugated tin roofing over the wood shingles. The rear wall of the main house, covered by the outshut, is sheathed with plain rough sawn weatherboards laid flush. There is no evidence of weathering on this sheathing and no evidence of rear windows, suggesting that the outshut is an original feature, not an addition.

Irwin Steele House  
Ingleside, Maryland  
Orlando Ridout V 1980  
View from North
